ENERGY EFFICIENT ENGINE

PIN FIN AND CERAMIC COMPOSITE SEGMENTED LINER

COMBUSTOR SECTOR RIG TEST REPORT

UNITED TECHNOLOGIES CORPORATION
Pratt & Whitney
Engineering Division

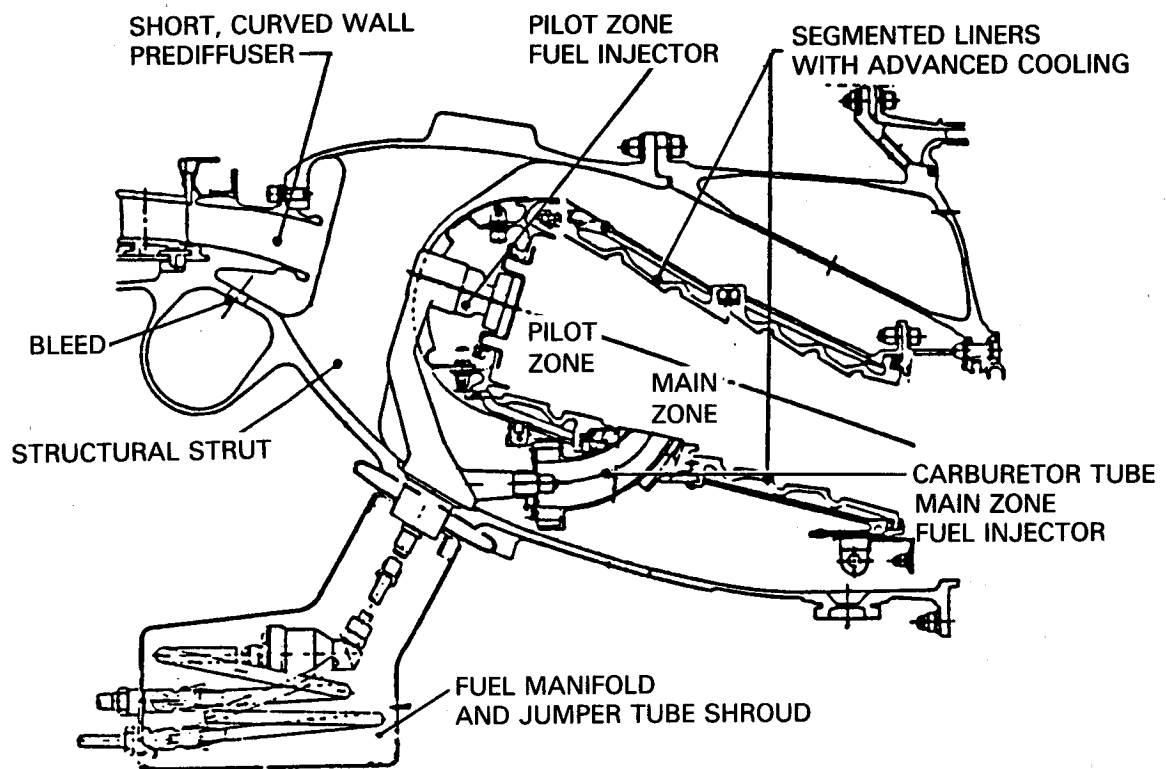
Figure 3-1 Energy Efficient Engine Combustor Design and Features

Both combustion zones are enclosed by a unique segmented liner construction. Although it represents a considerable departure from conventional louvered designs, this concept offers the potential for superior durability, better maintainability and the capability to operate at higher combustion pressure levels expected in future commercial aircraft propulsion systems. Advanced metallics as well as ceramic composite materials are both suitable for the segmented liner concept.

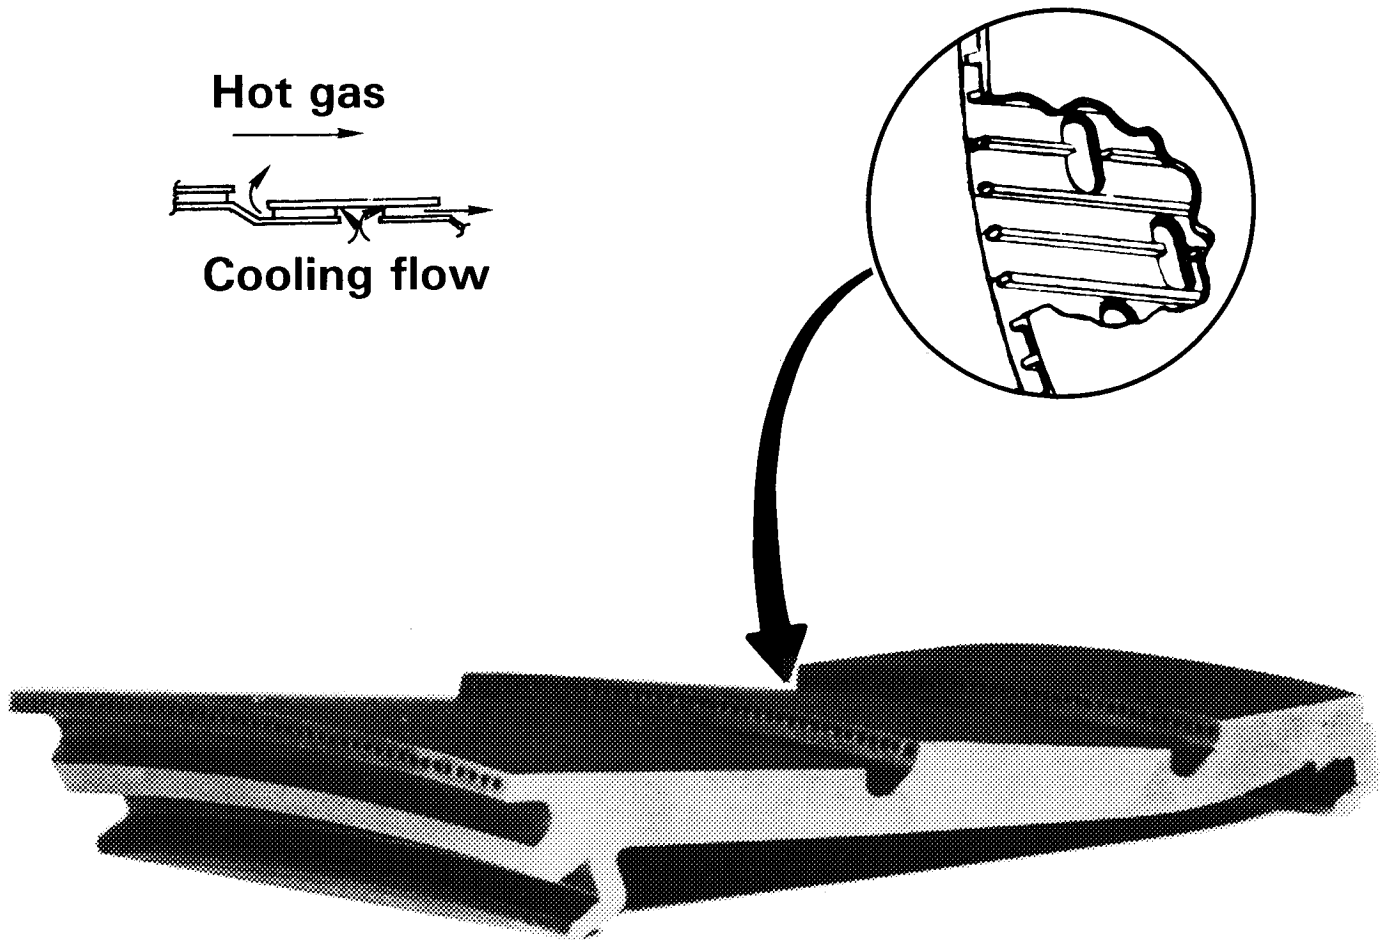
Figure 3-2 Advanced Segmented Liner With Counter-Parallel Finwall[®] (CPF) Cooling Technique

The CPFW liner configuration, shown in Figure 3-2, was the foundation on which the technology extension programs were built. The design details of this liner are fully documented in References 10 and 11. A brief overview is provided here for completeness.

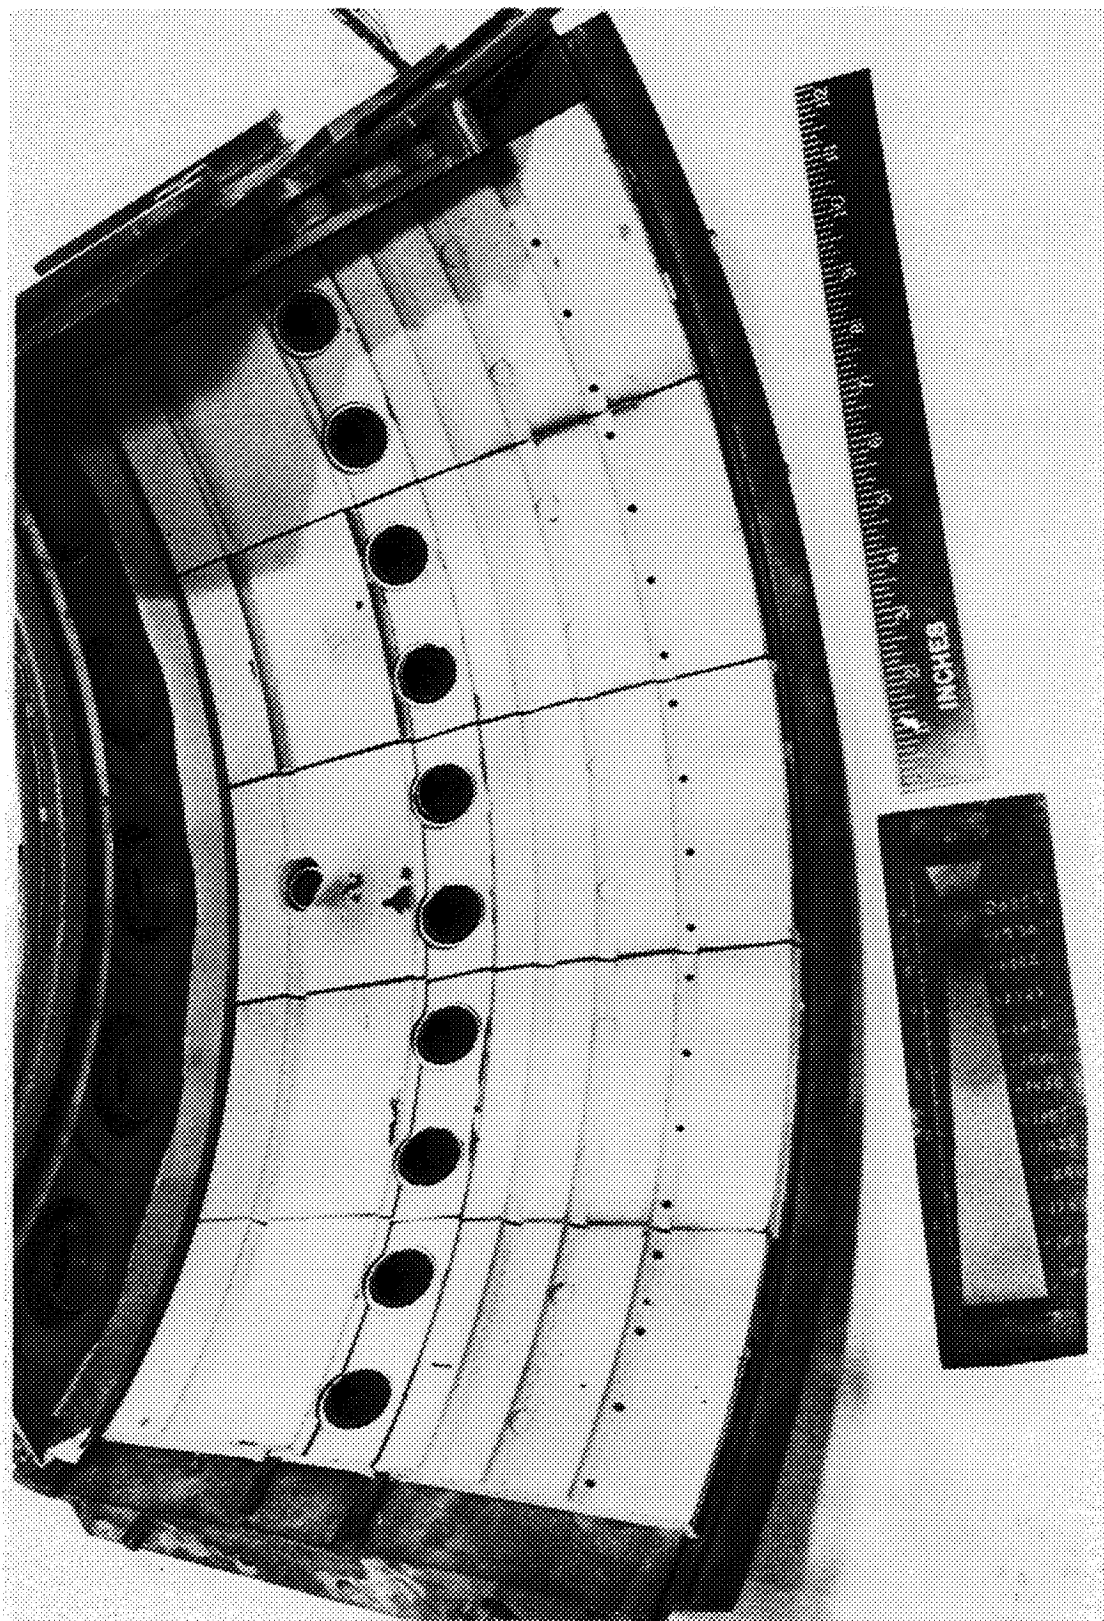
1
Figure 3-3 Sector Combustor Rig Outer Liner/Bulkhead Assembly

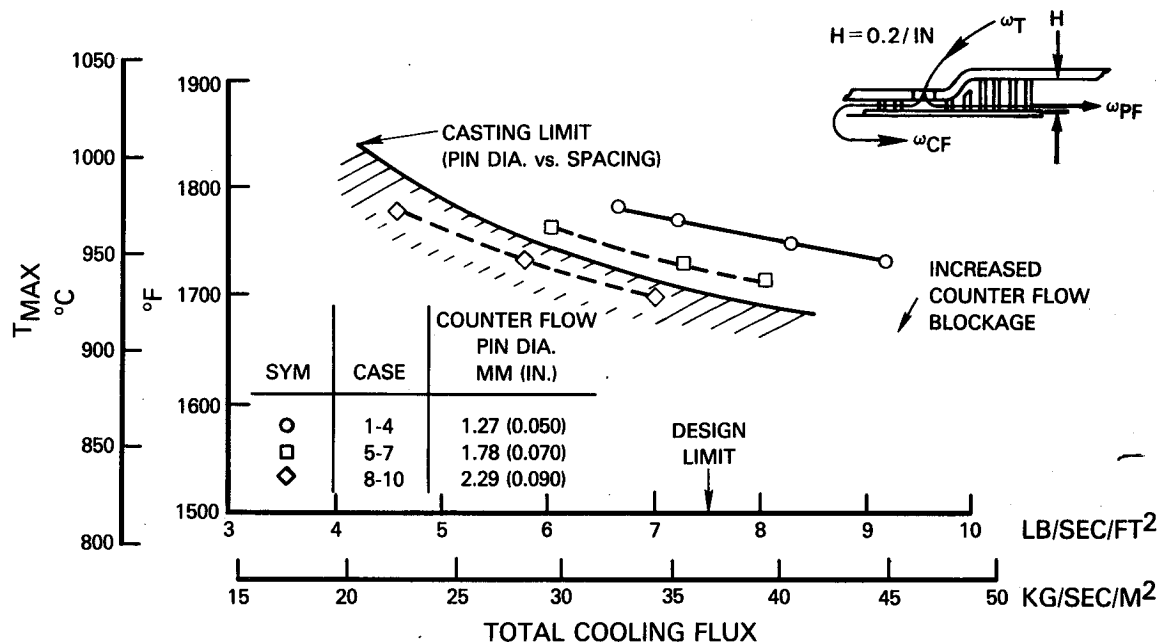
Figure 3-7 Maximum Wall Temperature Versus Total Cooling Flux

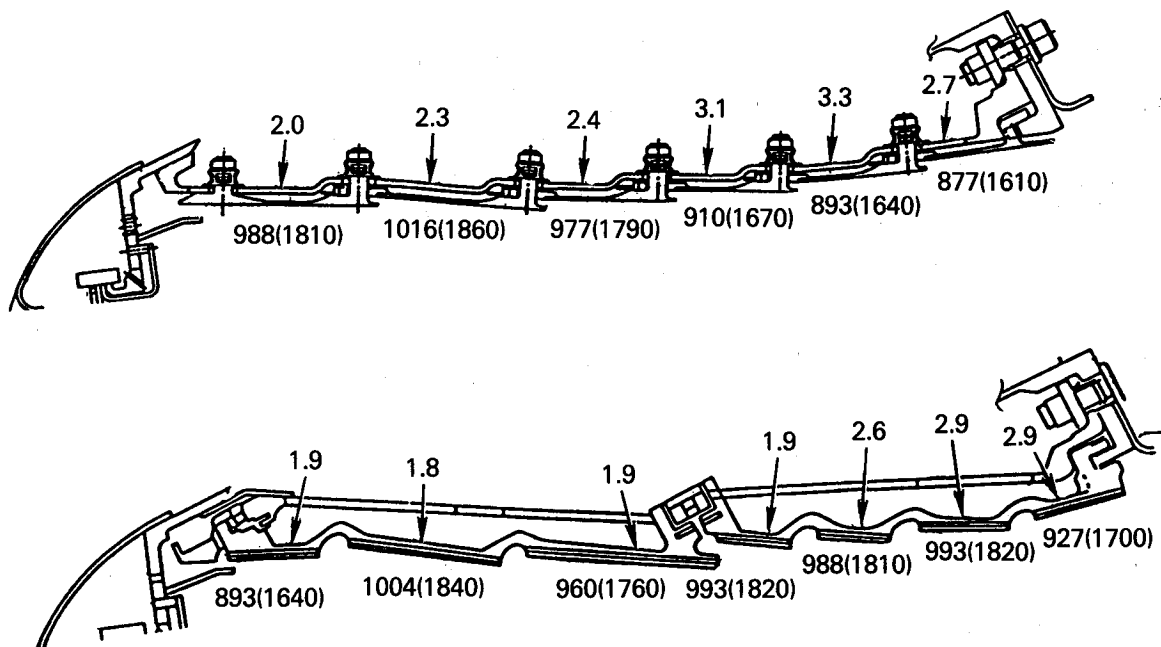
Figure 3-11 Comparison of CPFW and Pin-Fin Metal Temperature, °C (°F), and Cooling Flow Predictions

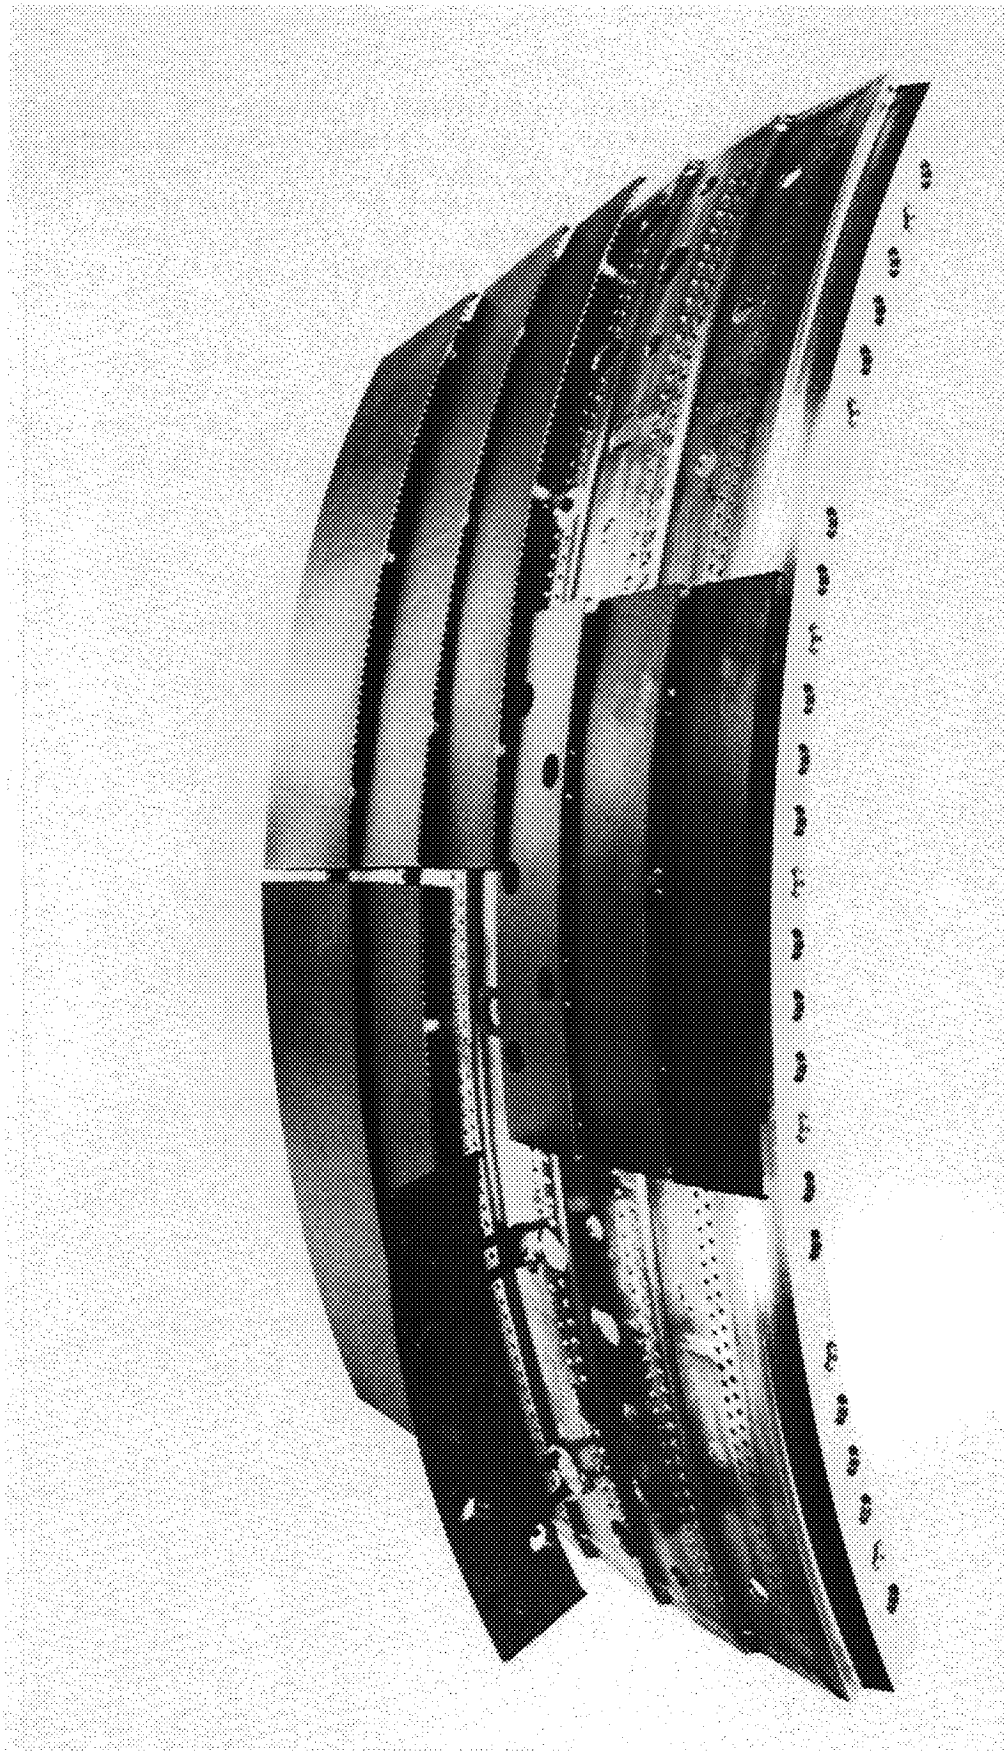
Figure 3-15 Sector Rig Shell and Cast Segments

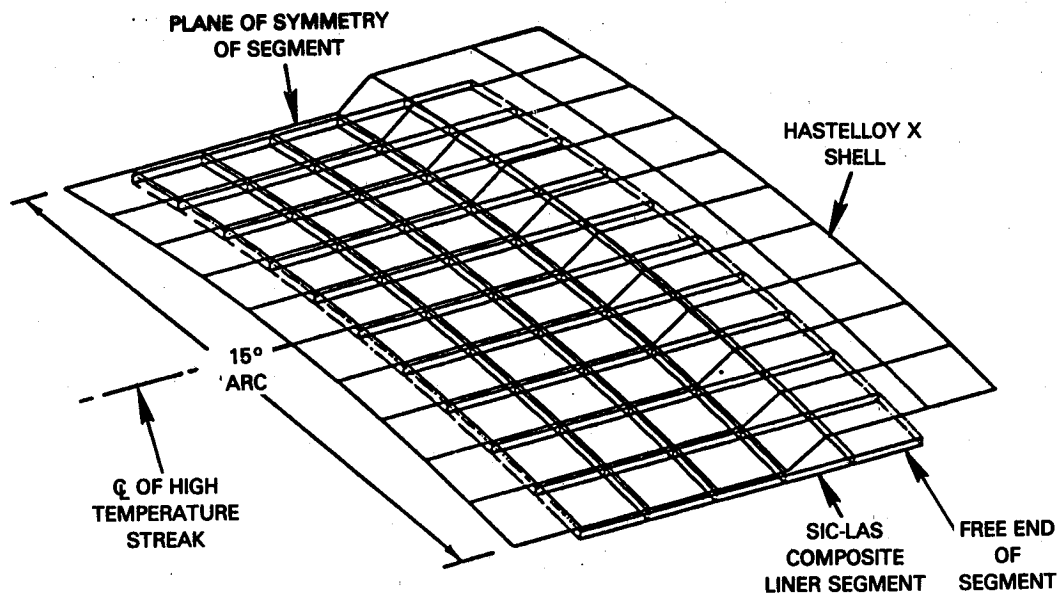
Figure 3-19 Structural Model of SiC-LAS Composite Liner

The radial stress components in the panel are higher near the attachments and almost nonexistent at the hot downstream lip. The radial stress is 22.7 MPa (3.29 ksi) in the compressive direction at the center attachment, while it is tensile and of considerably lower magnitude at the attachment near the free end. These stresses are caused by the changes in the radius of curvature of the panel and the shell. When both are heated to about the same temperature level, but with significantly different coefficients of expansion, radial loads develop in the attachments. This analysis was conducted for a composite panel on the inside surface of an outer liner shell. The loading would be reversed for a segment on the inner liner shell in that the center attachment would be loaded in tension and those at the free end in compression.

The magnitude of the axial components of stress in the panel was low and consequently the magnitude of the maximum stresses in the plane of the fibers is essentially that of the transverse components. On this basis, the highest stress levels encountered are about 58 MPa (8.5 ksi) in tension and these are in the cooler region near the attachment. In the hot regions of the panel, the maximum stresses are lower being nominally 55 MPa (8.5 ksi) in compression and 48 MPa (7 ksi) in tension. Based on flexure tests of the SIC-LAS material stresses of this magnitude are only about half those of the proportionality limit of the material. The use of the NASTRAN linear elastic analysis was appropriate and the in-plane stress levels in this type of liner constructions are low.

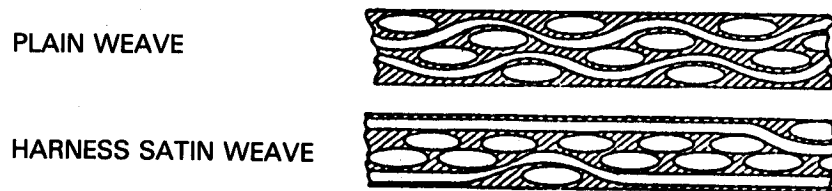
Figure 3-24 Schematic Representation of Woven Fiber Composite Materials

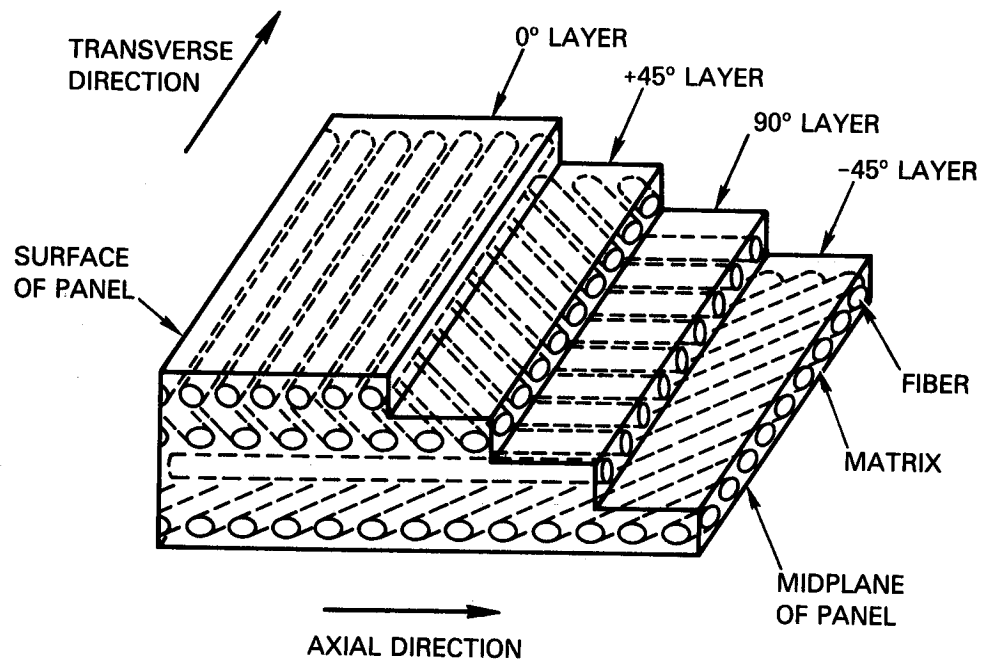
Figure 3-25 Schematic Representation of Improved Fiber Orientation in Ceramic Composite Panels

A change in the fiber layup for the basic multi-directional fiber layer type of construction was also introduced. With reference to Figure 3-18 the sequence of orientations of the fiber layers in the original panel definition was 0°/+45°/-45°/90° when progressing from the surface to the mid-depth plane. However, it was observed that the change in fiber direction at each interface was 45° except for the 90° change encountered between the +45° and the -45° layer and it was felt that the resistance to interlaminar shear could be increased if the changes in direction of the fibers were restricted to 45° at all interfaces. This could be readily accomplished by changing to the 0°/+45°/90°/-45° fiber orientation sequence shown on Figure 3-25 without compromising the desired orthotropy of properties in the in-plane direction.

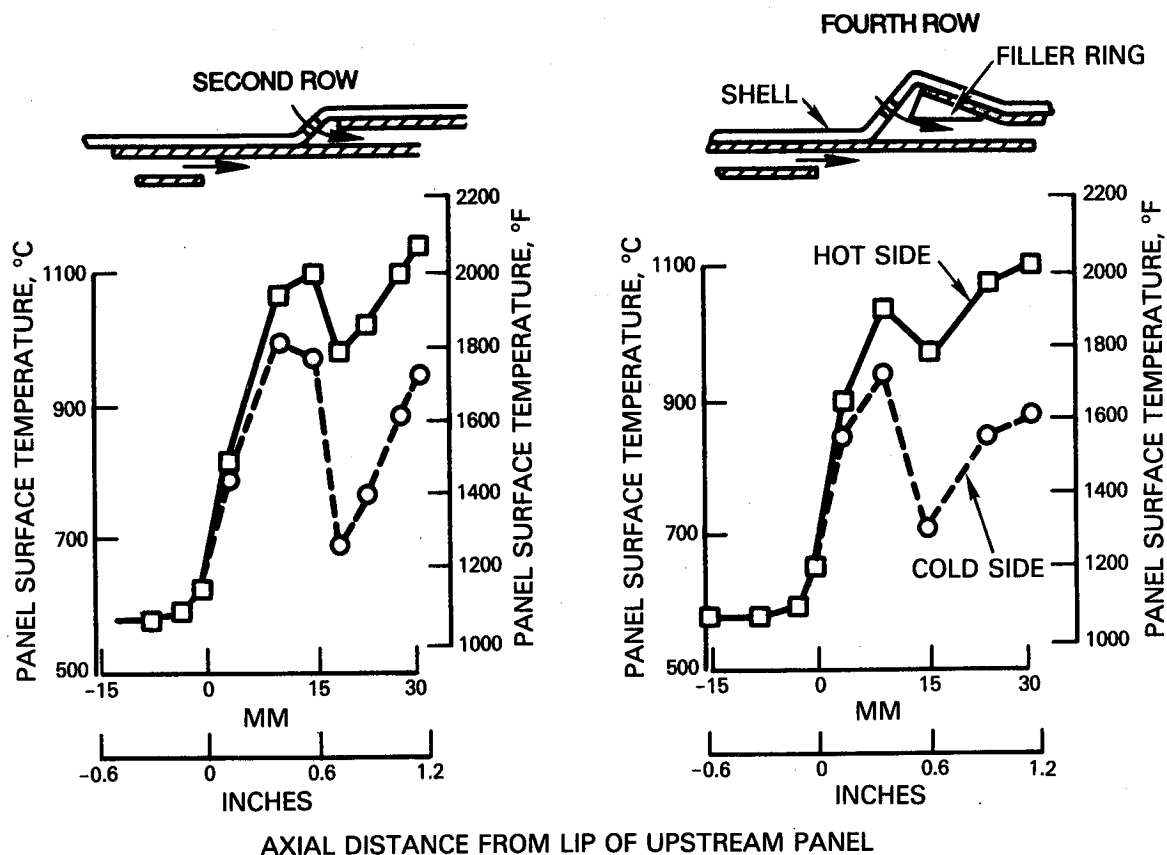
Figure 3-26 shows the computed temperature distributions on the surfaces of panels in Rows 2 and 4 in the combustor liner. The Row 2 panel has a relatively long part of the panel downstream of the lip in contact with the shell and a shorter region with active convective cooling on the cold side and is representative of Rows 1, 2, 5, 6, and 7 in this respect. Conversely Row 4 panels have active cold side convective cooling over a greater part of its length which is also typical of Row 3 panels. The thermal analyses were conducted for two different sets of thermal boundary conditions: a nominal or circumferential average condition and a hot-streak condition which could occur at circumferential positions where the local combustion gas temperature was higher than average because of proximity to a fuel injector or the cooling film or the surface of the panel was deteriorated by blockage by an attachment bolt head or interaction with a dilution air jet. The temperature distributions shown in Figure 3-26 were computed at the streak locations and hence are the maximum anticipated temperatures in the panel.

Figure 3-26 Surface Temperature Distributions in Representative Composite Panels in the Sector Combustor Rig

The computed temperature distributions show strong parallels with that of Figure 3-17 which was generated during the initial conceptual design study. Progressing downstream from the lip of the preceding panel, the surface temperatures increase abruptly reaching a first peak prior to the point of cooling air injection behind the panel and then progress to a second peak at the downstream end as the cooling air film deteriorates on the hot surface. Through thickness temperature differentials reach 200°C to 250°C (360°F to 450°F) and are highest either in the vicinity of the point of impingement of the cooling air on the cold surface or at the downstream lip. The maximum face temperatures occur at the downstream lip and are between 1100°C and 1150°C (2000°F to 2100°F).

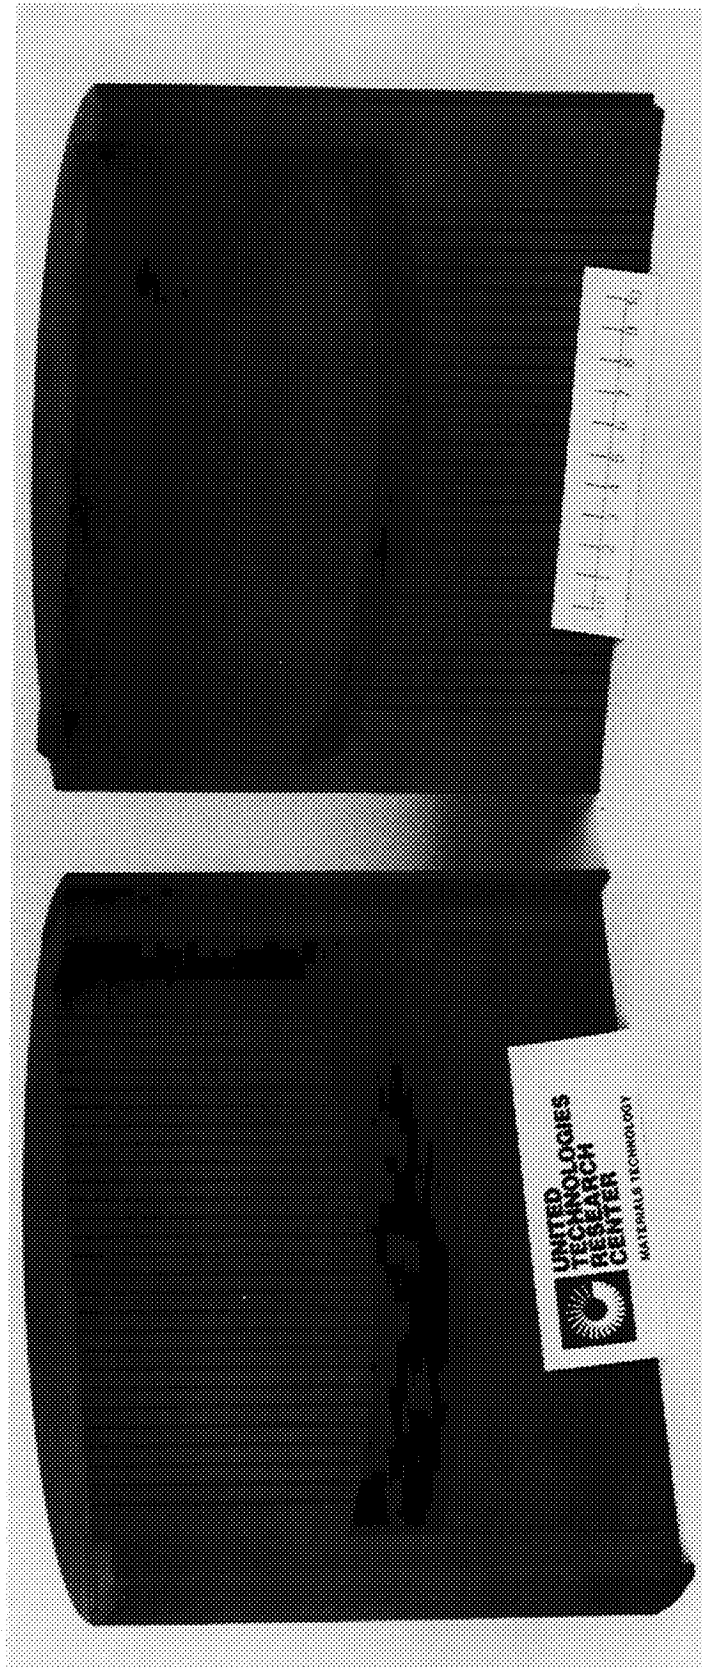
Figure 3-29 Die for Hot Pressing a Panel of the EEE Combustor Rig Liner

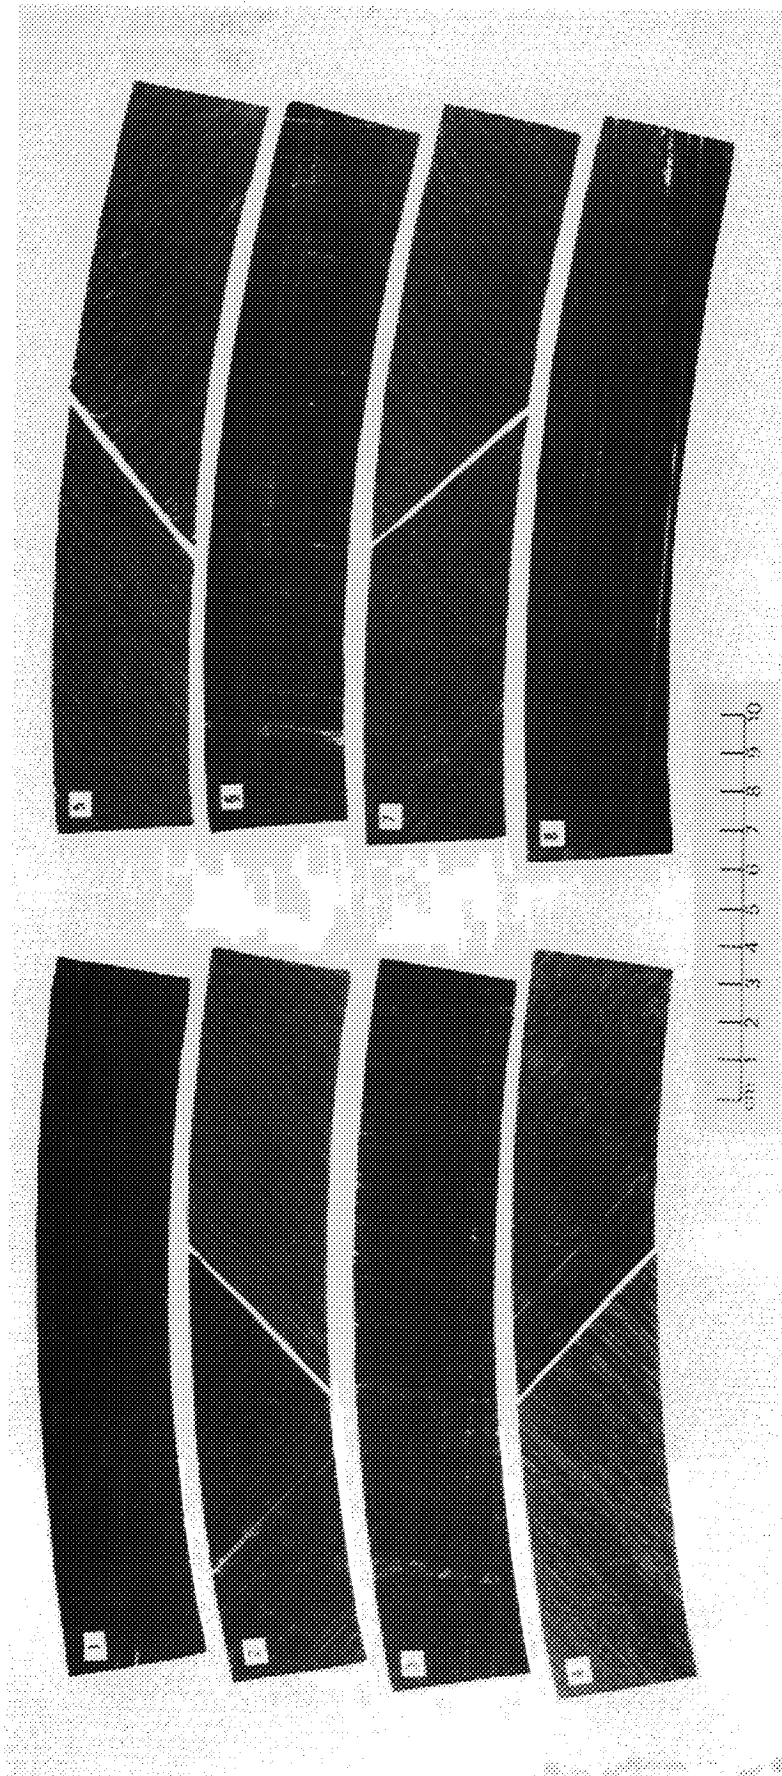
Figure 3-30 Eight Silicon Carbide Fiber Plies used to Construct a Liner
Panel (Numbers Indicate Stacking Sequence)

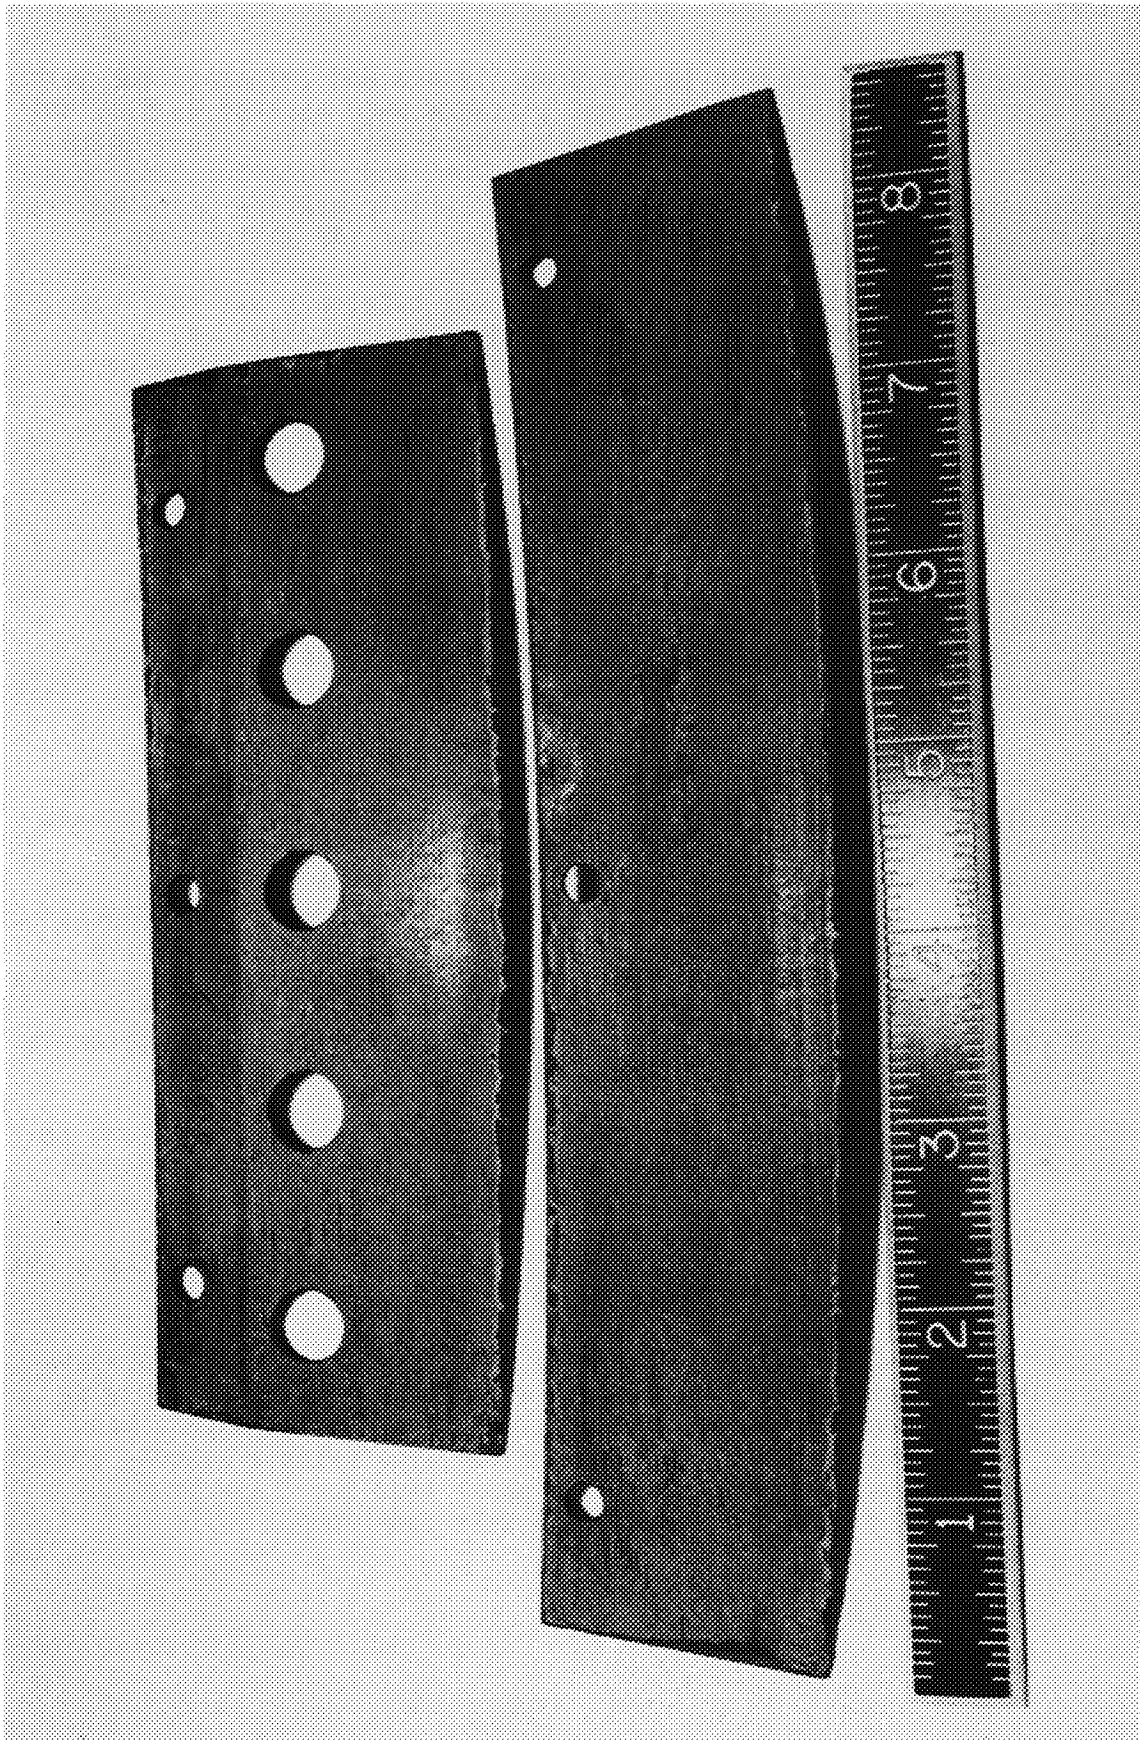
Figure 3-31 Panels from Row 5 (Top) and Row 3 (Bottom) of Liner After
Drilling and End Trimming Operations (Ruler Scale in Inches)

During a trial assembly the short ends of the panels were trimmed to achieve the proper cold transverse clearance between adjacent panels and to provide for panel to endwall gap. The trimming operation was performed with a hand held grinding wheel removing material to a scribed line using a diamond bonded wheel. Figure 3-31 shows a closeup view of a panel from Row 3 and from Row 5 of the liner after these machining operations were completed.

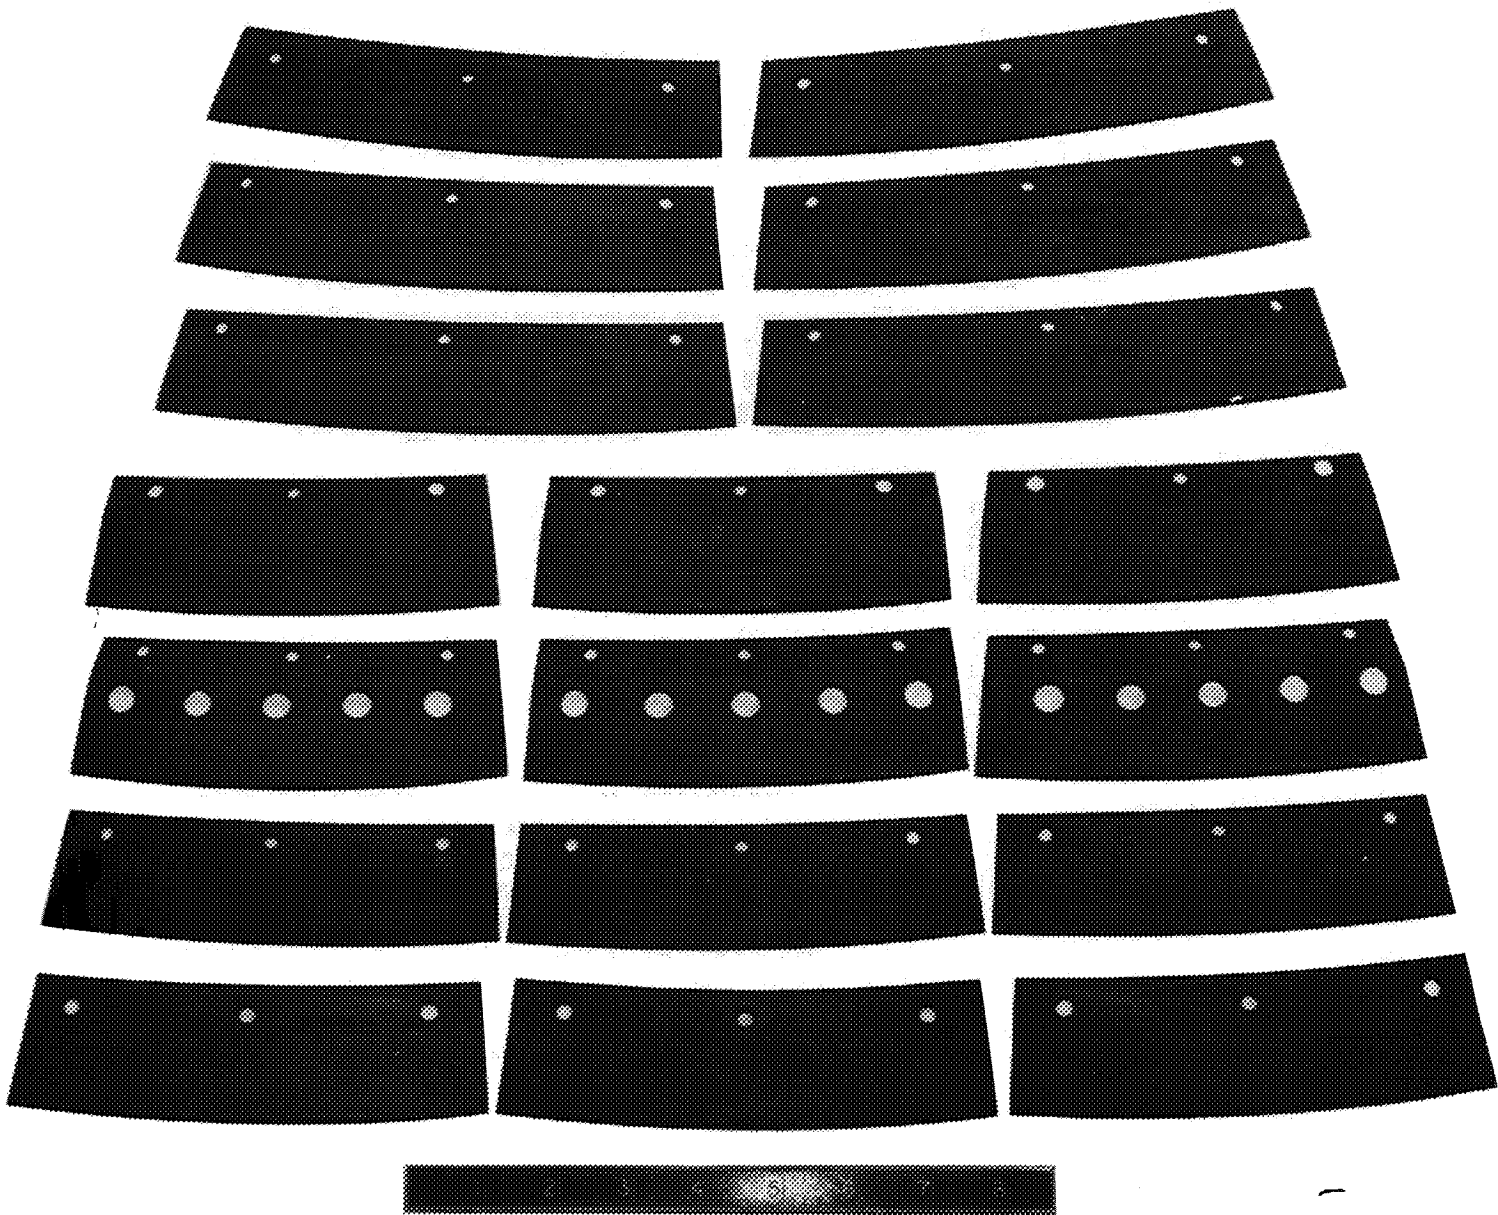
Figure 3-32 Complete Set of Ceramic Composite Liner Panels for EEE Combustor
Rig Inner Liner (Ruler Scale in Inches)

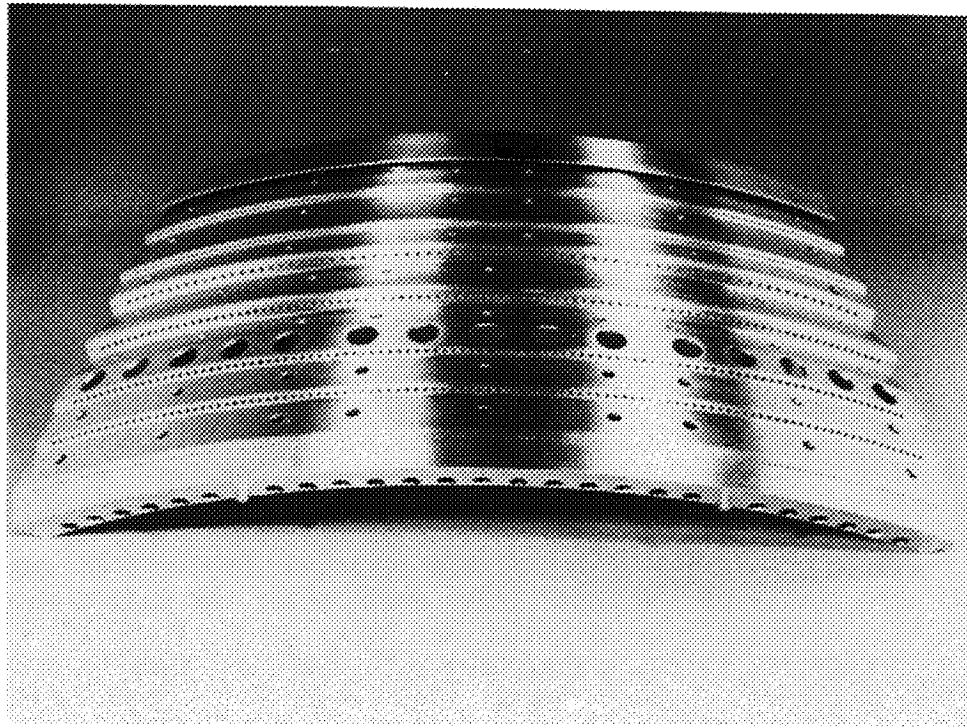
Figure 3-33 Inner Burner Liner Shell for Ceramic Composite Liner

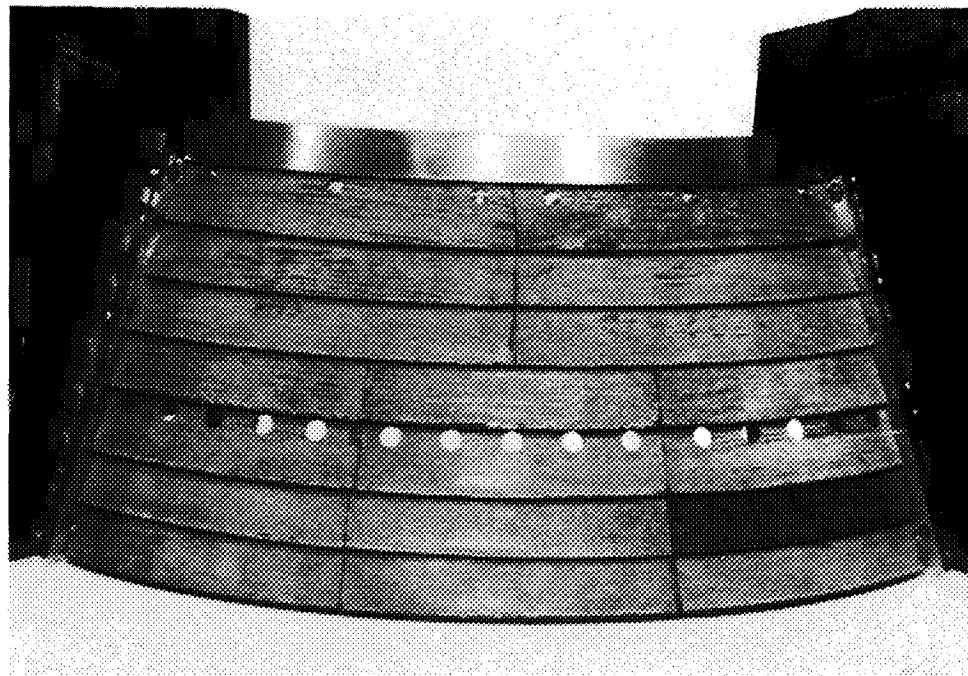
Figure 3-34 Ceramic Composite Liner Panels Installed on Inner Liner Shell of Combustor Sector Rig

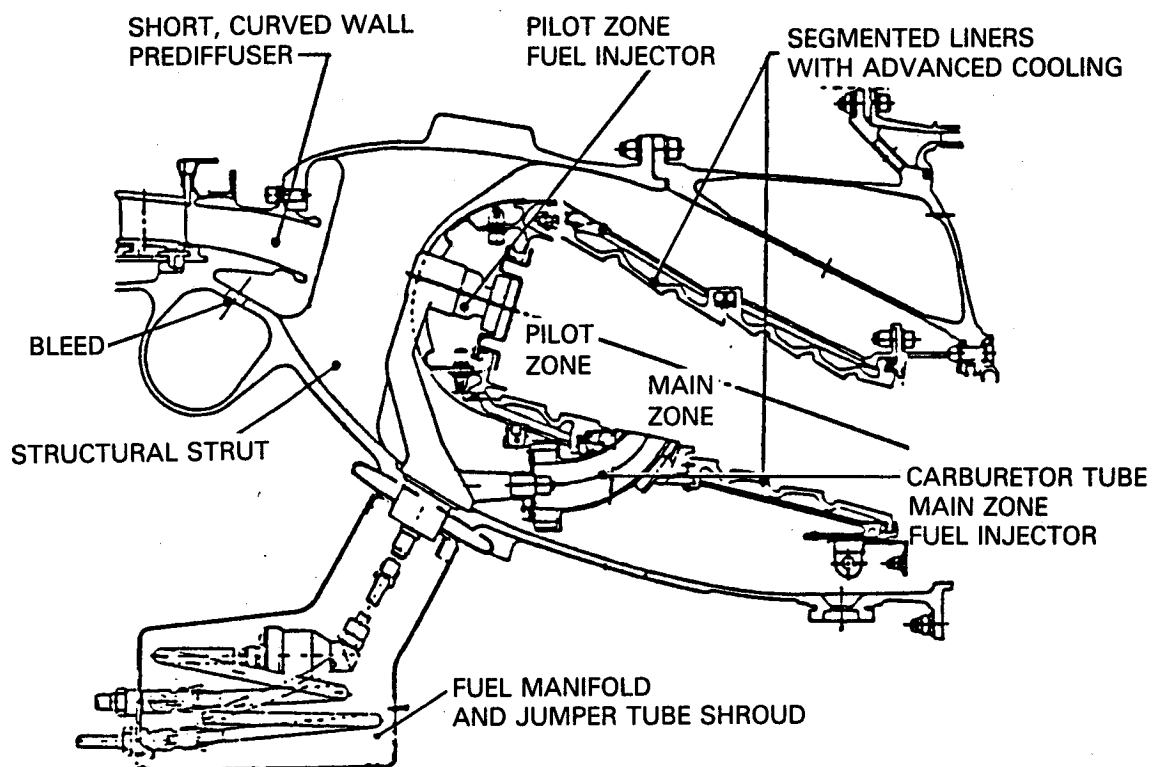
Figure 4-1 Cross Sectional View of Sector Combustor Test Rig

In this stand, the test rig was mounted within a cylindrical pressure tank. Tank pressurization was automatically controlled to 6 psi above rig pressure. In this manner, the pressure load was supported by the facility pressure vessel, permitting the experimental hardware to be of relatively light construction. The thermal load was carried by the test rig. The main tank was cooled with an amount of purge air equal to 5 to 10 percent of combustor inlet airflow. A retractable tank section with a quick-connect breech-lock seal was provided to enable easy access to the test rig.

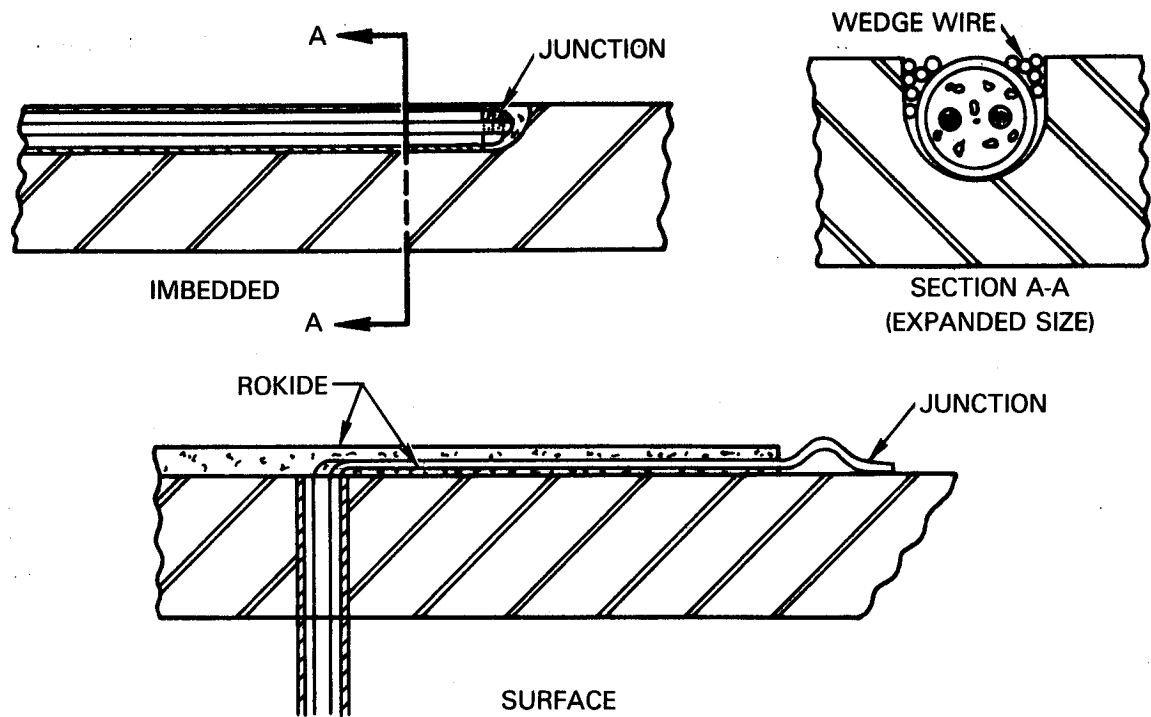
Figure 4-2 Installation of Chromel/Alumel Thermocouples

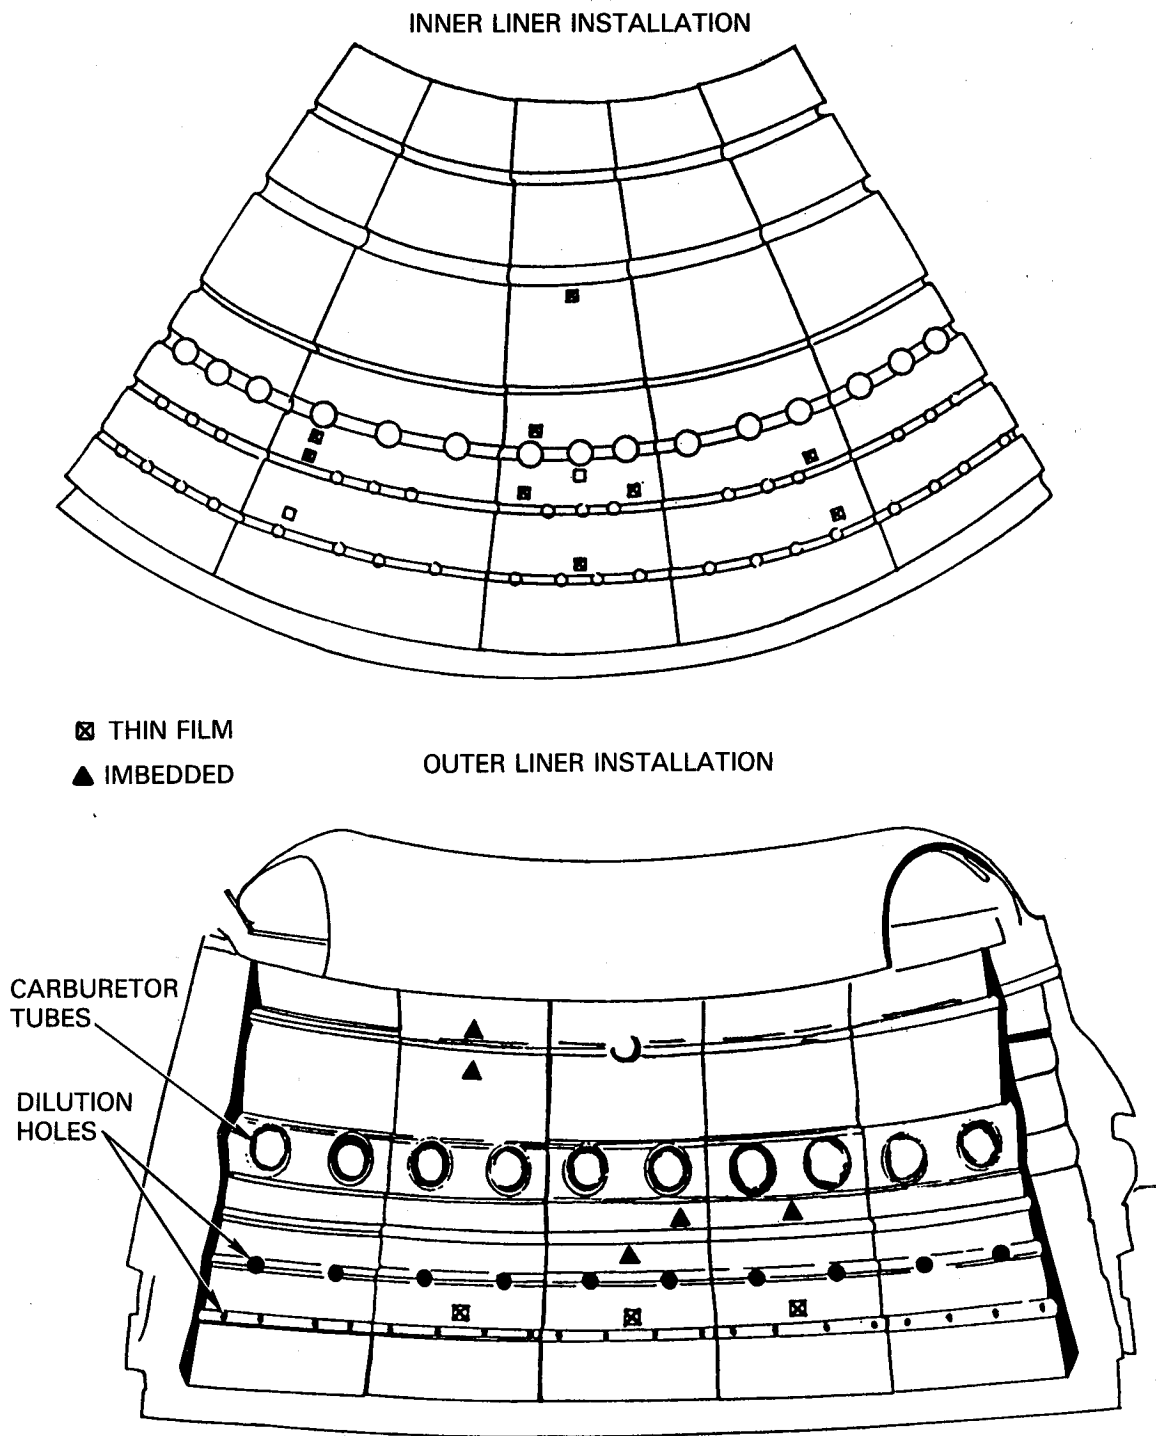
Figure 4-4 Thermocouple Installation for Run 23
